United States Environmental Protection Agency
Washington, D.C. 20460
Water Compliance Inspection Report

AES PUERTO RICO, L.P.

Coal-Fired Steam Power Plant

**Enforcement Case Support Inspection Report
Industrial Site Inspection**

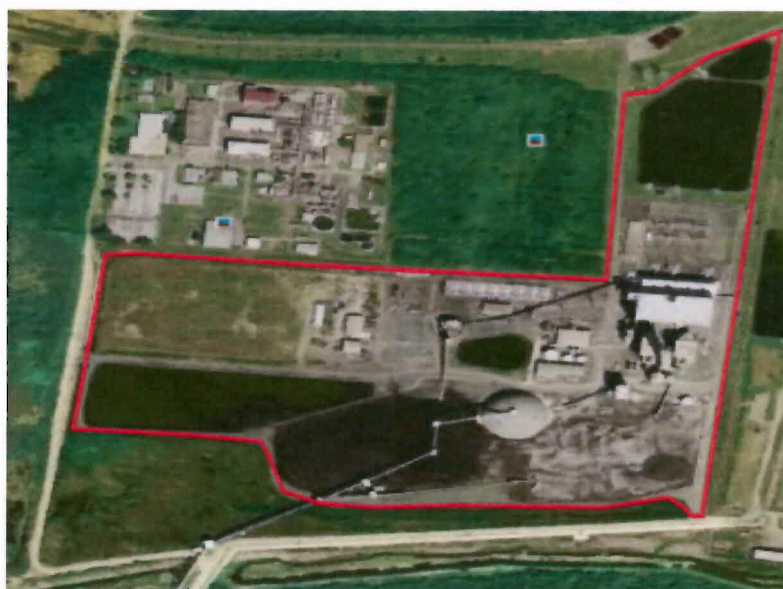
Figure 1

- a. The Site is a gated 84-acre parcel of land and leveled above the 100-year flood elevation. AES employs about 130 employees.
- b. The Facility is bordered to the north by TAPI Puerto Rico Inc. pharmaceutical facility and open lands owned by the Puerto Rico Land Administration (PRLA); to the east by Chevron Phillips Chemical Puerto Rico Core Inc. (CPC) former petrochemical complex; to the south by wetlands and Las Mareas Bay; and to the west by AES Ilumina, LLC, photovoltaic power generation complex. **Figure 1** below depicts an aerial view of the Site (source: Google Earth).¹

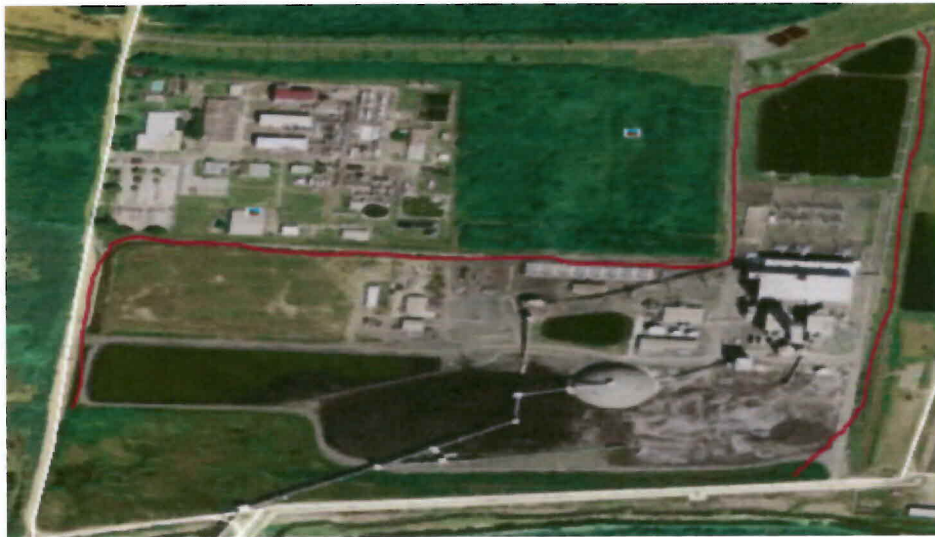
Figure 2

- e. The Facility has two (2) distinct storm water collection and discharge systems that serve to collect and convey storm water runoff generated at adjacent properties (north and northwest of the Site and between TAPI and the Facility) into wetlands. The storm water runoff collected and discharged into wetlands it is not regulated under Section 402(p) of the CWA and its implementing regulations at 40 C.F.R. § 122.26 because these discharges are not associated with any industrial activity at the Site. **Figure 2** depicts the approximate location of these systems.

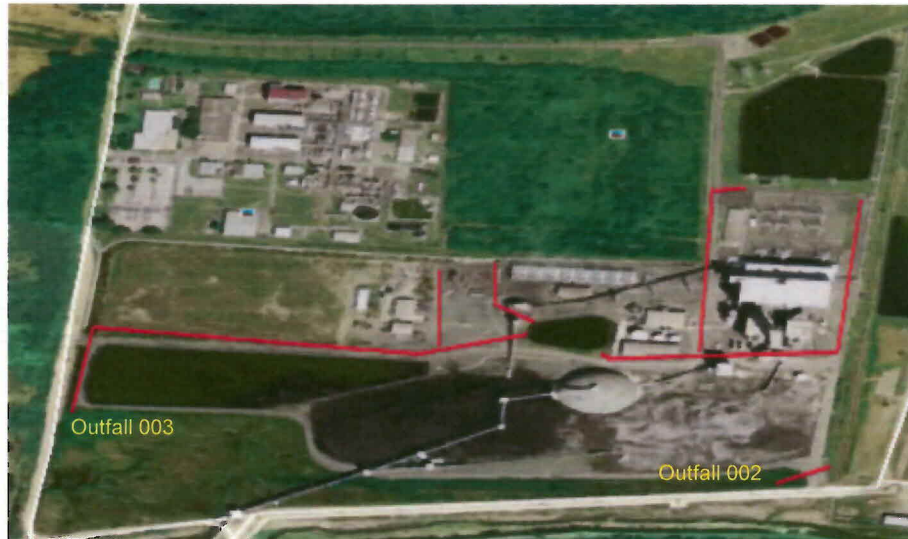
Figure 3 – Storm Water Collection and Discharge Locations

- f. The regulated storm water runoff associated with the industrial activities at the Facility is handled through two (2) collection and discharge systems mainly composed of inlets, culverts, swales, concrete channels, Storm Water Runoff

Pond, and two (2) discharge points into adjacent wetlands located on the south boundary of the Site. AES reuses the storm water runoff collected in the Storm Water Runoff Pond and the Coal Pile Runoff Pond, by means of transferring the collected water to the Make-up Water Pond, which is used in power generating activities. **Figure 3** depicts the approximate location of these systems.

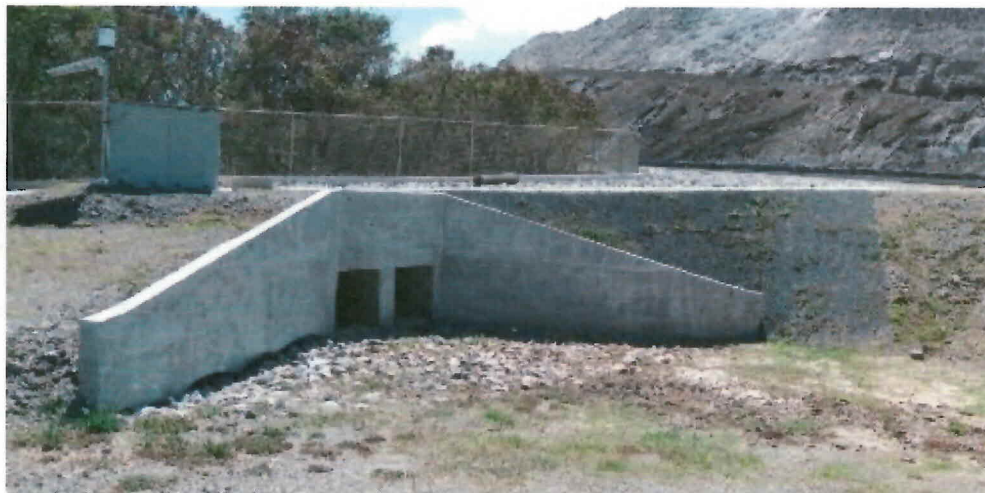
Picture 1 – Concrete Box Culvert

- g. **Picture 1** depicts the concrete box culvert that conveys the storm water runoff from the east areas of the Site through outfall 002. This picture also depicts an automatic sampler and weather station powered by solar energy. **Picture 2** depicts the outfall 002. **Picture 3** depicts the sampling point for outfall 002.

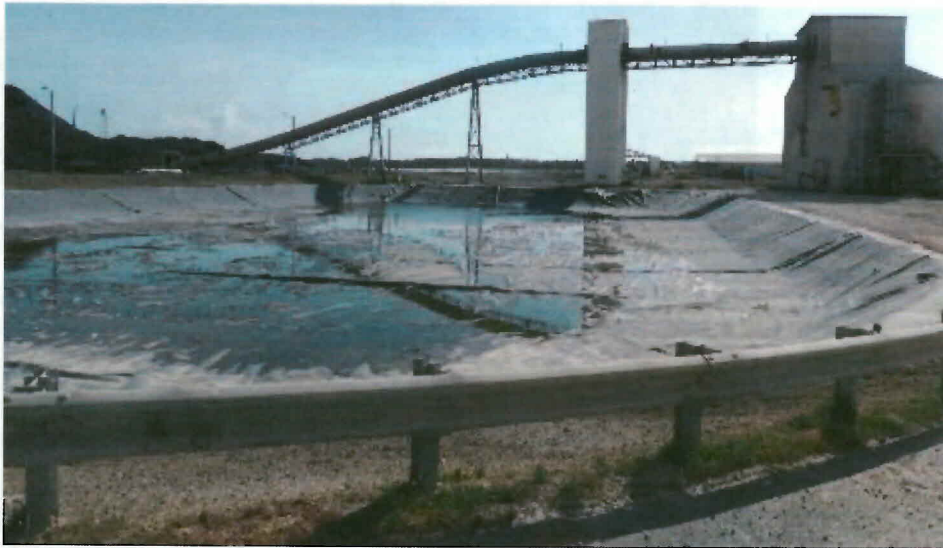
Picture 4 – Storm Water Runoff Pond

- h. Most of the storm water runoff associated with industrial activities within the Site's central areas (e.g., roof drains, yards, internal roads) is conveyed into the Storm Water Runoff Pond for water re-use. During the rain events that exceeds this Pond holding time, an overflow takes place into a swale covered with rip-rap. This swale discharges into a concrete channel that ultimately flows into the wetlands.
- i. **Picture 4** depicts the Storm Water Runoff Pond, which was enlarged and provided with a new synthetic liner.

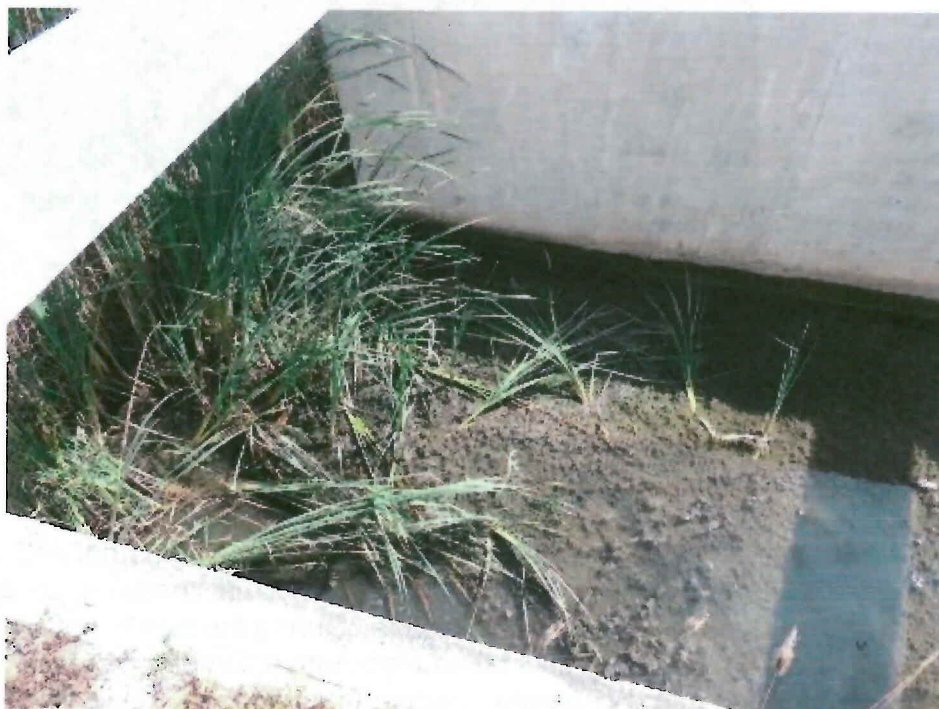
Picture 5 – Outfall 003

- j. **Picture 5 depicts the outfall 003.**

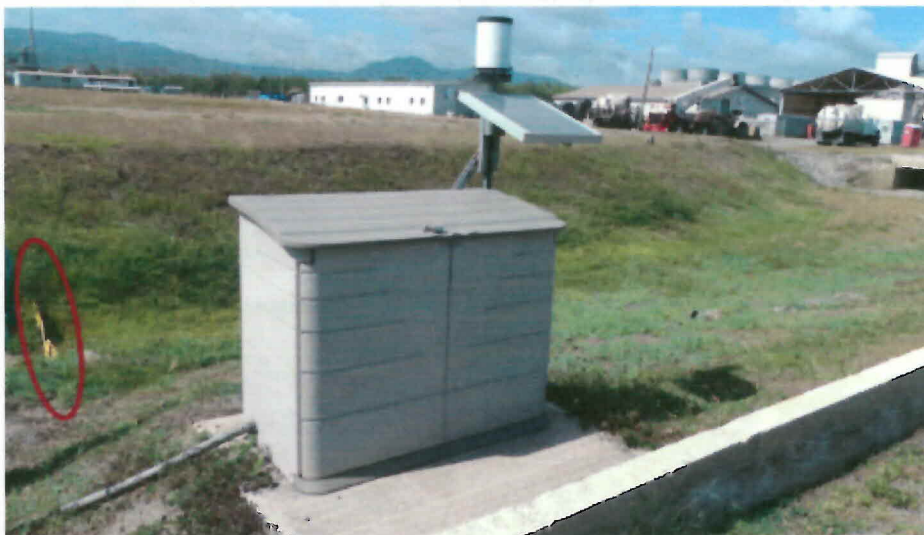
Picture 6 – Sampling Point for Outfall 003

- k. **Picture 6 depicts the sampling point for outfall 002 (see red ellipse), which is located at an elevation that will not be affected by flooding during a 100-year storm.**

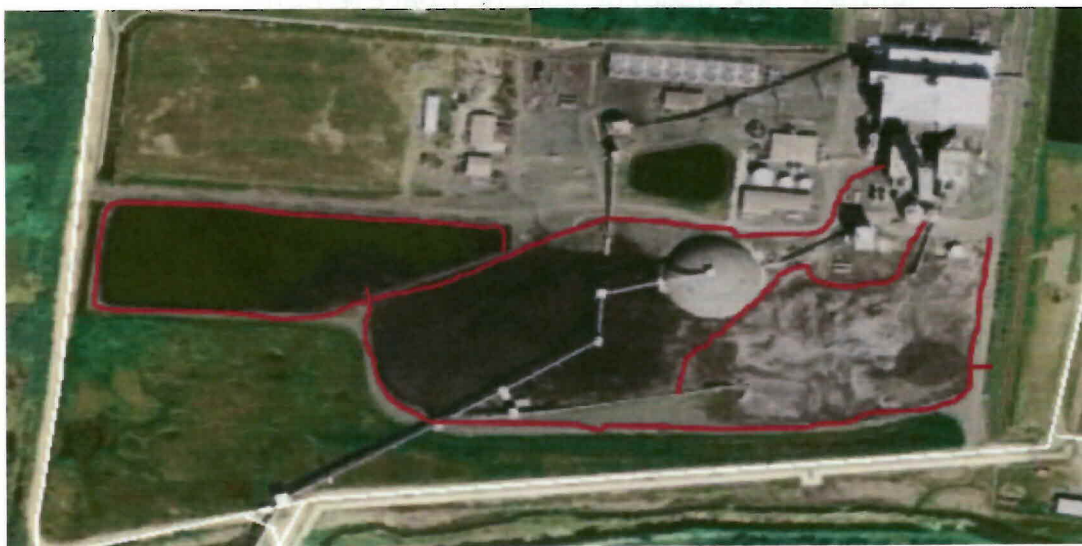
- I. The storm water runoff and process wastewater from areas in which fly/bed ashes, Aggremax™, limestone and coal are handled, including internal access roads, are conveyed through concrete swales into the Coal Pile Pond for water re-used (e.g., dust control in Aggremax™ pile, hydration of fly/bed ash mixture, Make-up Water Pond). The Coal Pile Pond does not have a discharge structure.
- m. **Figure 4** depicts the collection and conveyance system into the Coal Pile Runoff Pond.

Figure 4 – Conveyance System into Coal Pile Pond

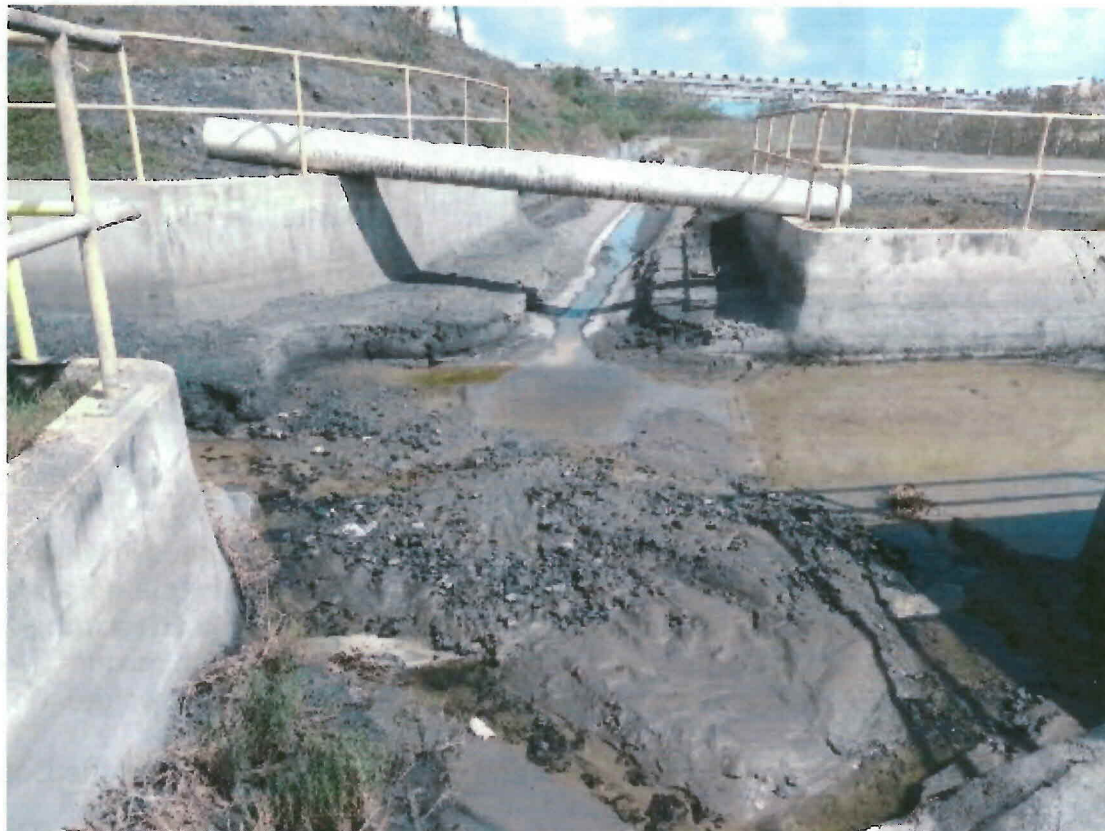
Picture 7 – Commingling of Concrete Swales

- n. **Picture 7** depicts the location in which the concrete swales located on the north and south storage areas commingle before discharging into the Coal Pile Pond.

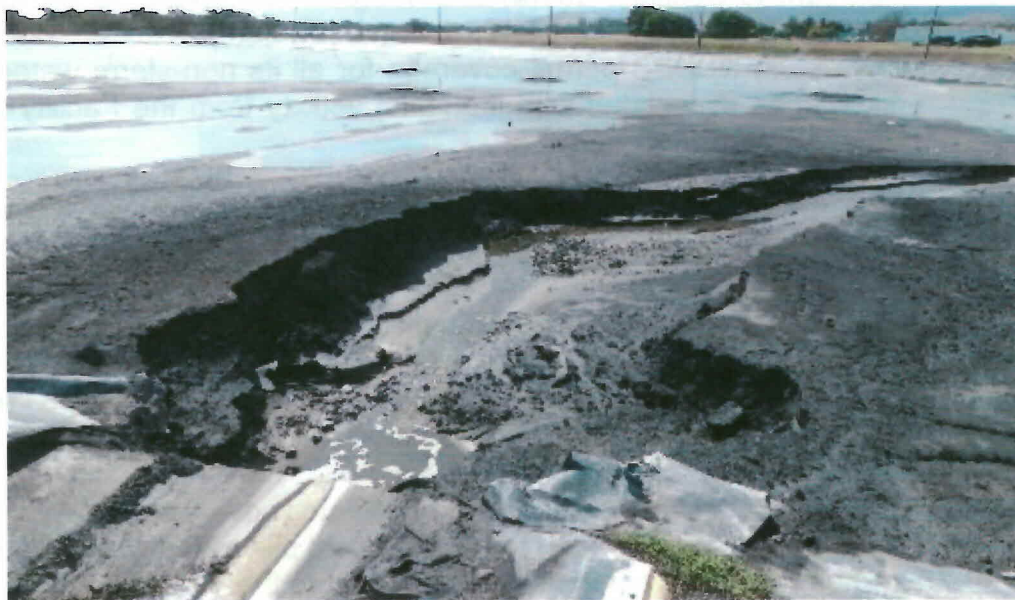
Picture 8 – Coal Pile Runoff Pond

- o. **Picture 8** (next page) depicts the Coal Pile Pond.
- p. The storm water associated with industrial and non-storm water (as authorized in the MSGP) are discharged into wetlands adjacent to Las Mareas Bay. The wetlands are a water of the United States. Las Mareas Bay is a navigable water of the United States.
- q. **Figure 5** (next page) depicts a portion of the hydrologic areas near Site, including Las Mareas Bay.

- 5) Action Item 68 (Approved Due Date: September 21, 2013) – Cleaning and repair of liner associated with the Coal Pile Runoff Pond;
- 6) Action Item 71 (Approved Due Date: June 14, 2013) – Installation of roof over water clarifying chemical storage totes for spill prevention; and

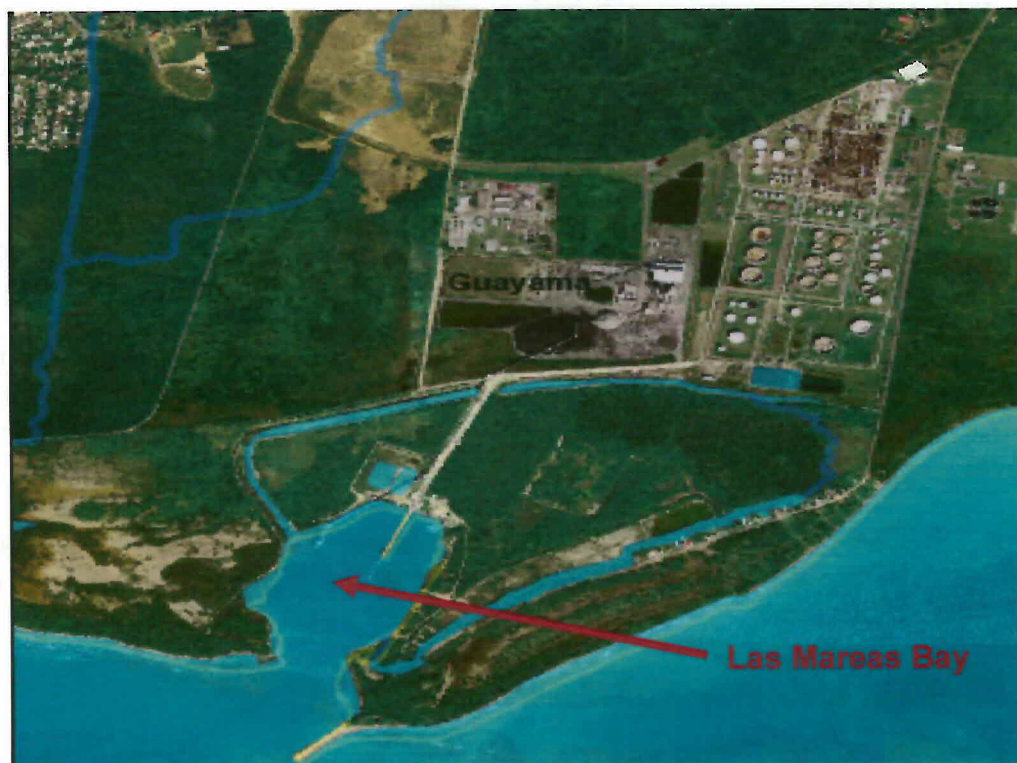
Figure 5 – Hydrologic Areas near Site

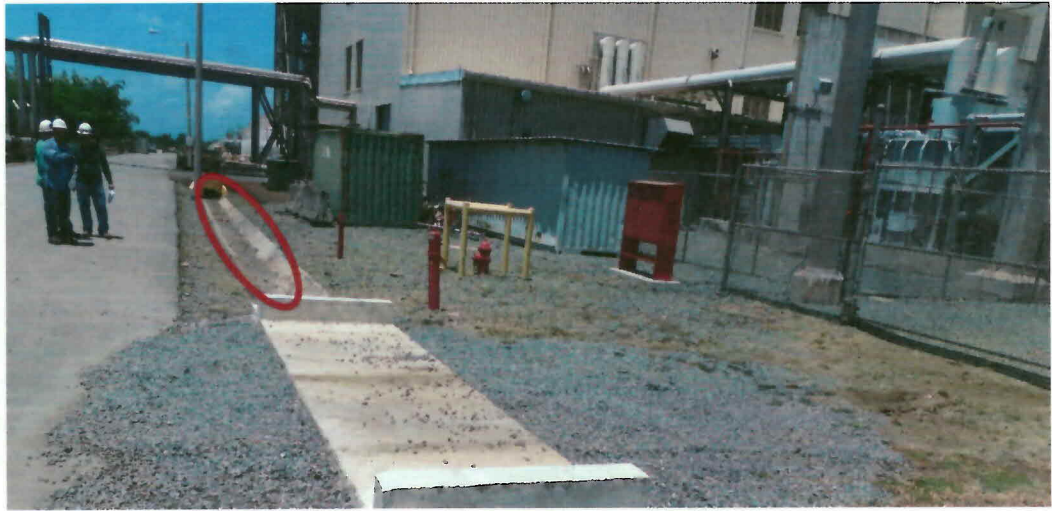
Picture 9

- 1) **Finding:** The storm water concrete swale located on the west area of the Site (near the electrical grid) was observed with sediment and gravel accumulation, and lacking good housekeeping. **Picture 9** depicts this finding.

⁹ AES does not have a mechanical sweeper to remove sediments, gravel and fine particles from Plant's areas.

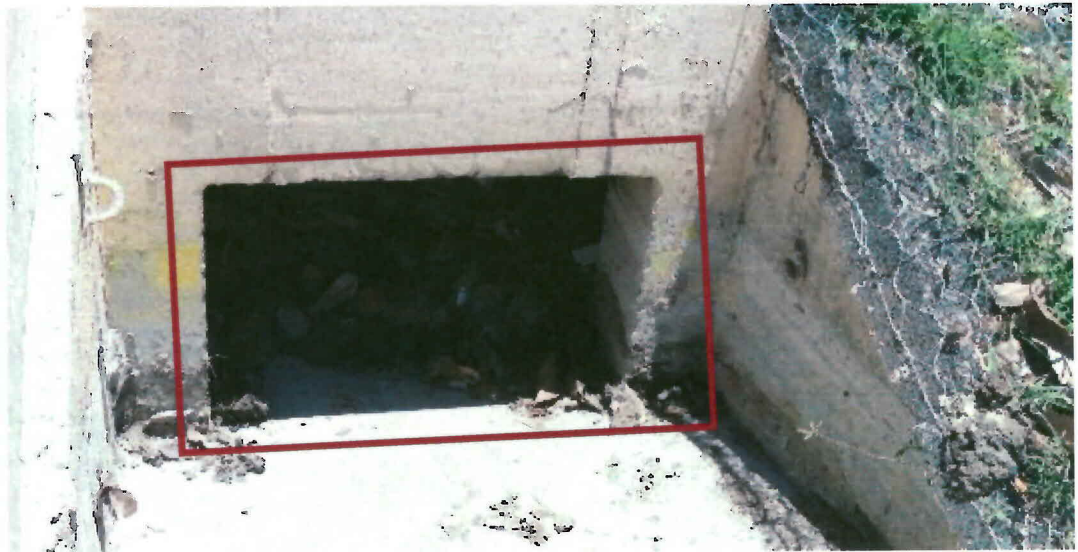
Picture 10

- 2) **Finding:** The storm water concrete culvert located beneath the fly ash loading area was found with debris, sediment, and ash, and lacked maintenance. **Picture 10** depicts this finding.

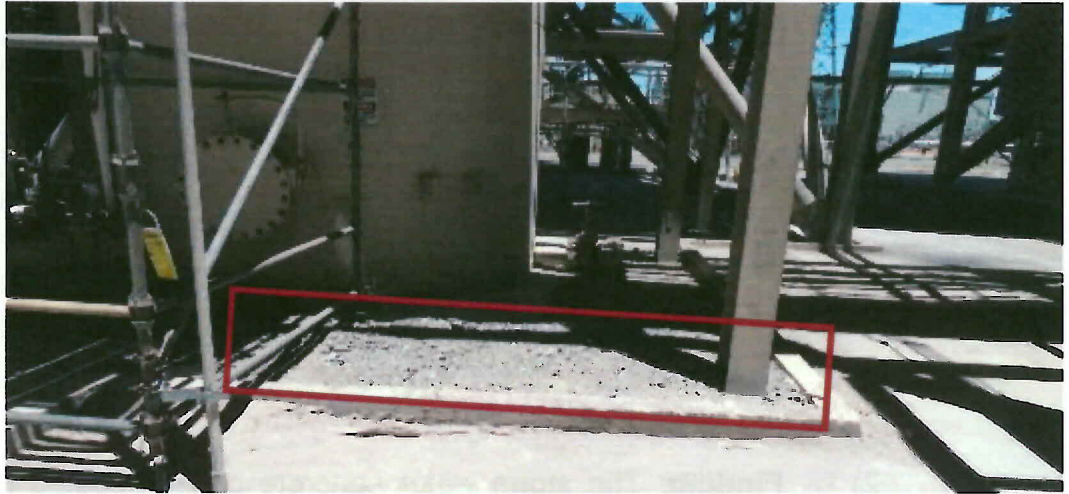
Picture 11

- 1) **Finding:** Crushed stone construction residues were observed inside a containment area (CDS/ESP) reducing containment capacity. **Picture 11** depicts this finding.

- c. **Requirement: Maintenance** (Part 2.1.2.3) – Regularly maintain and repair systems to avoid situations that may result in releases of pollutants in storm water discharged to receiving waters. Maintain all control measures that are used to achieve the effluent limits in effective operating condition.

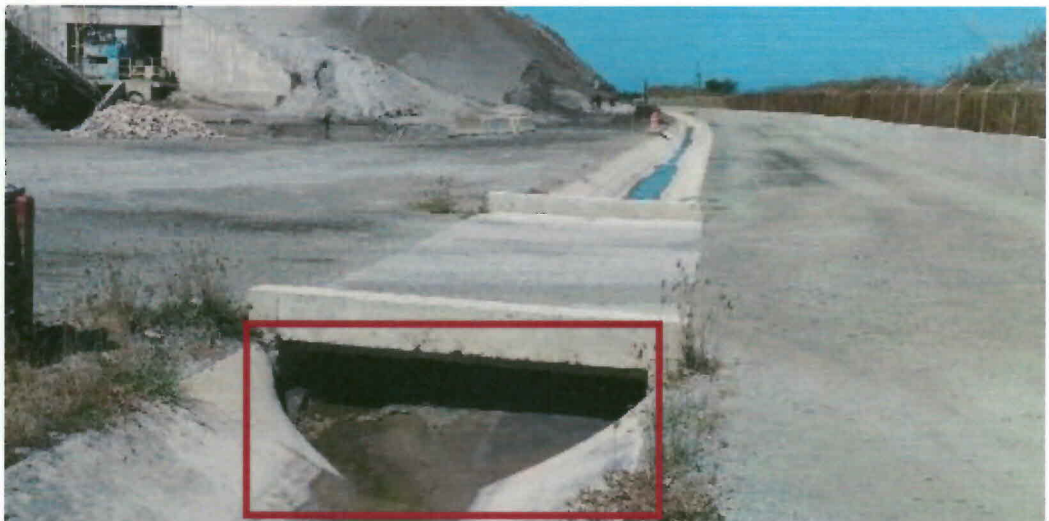
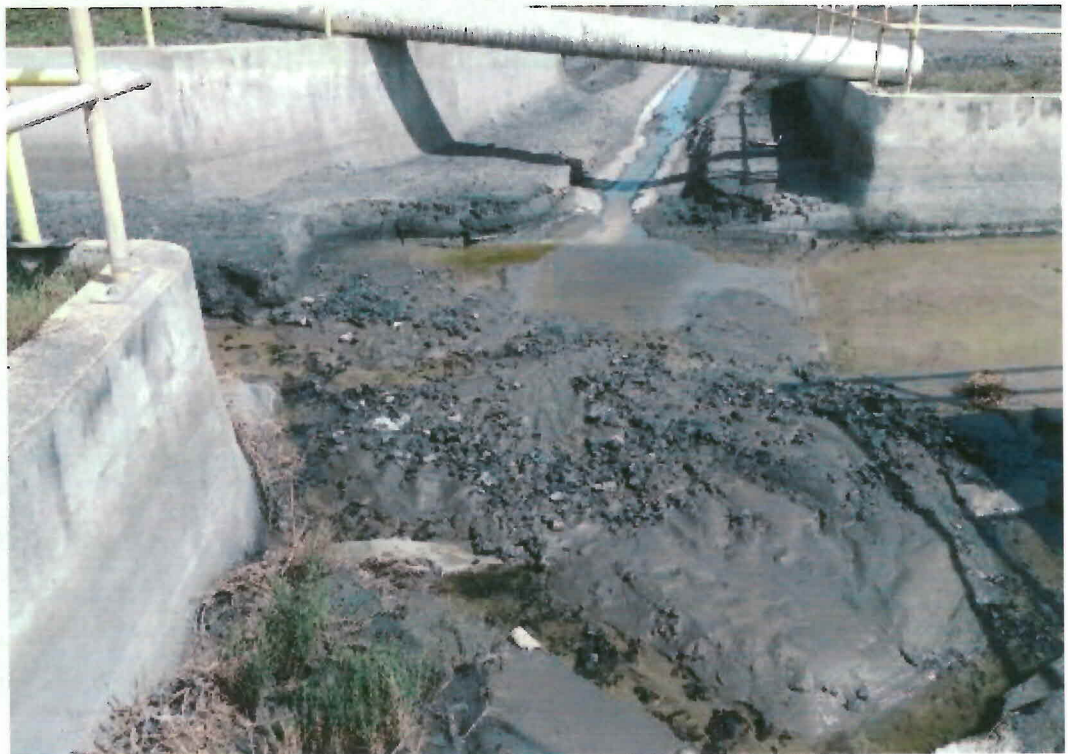
- 2) **Finding:** The concrete swale along the Aggremax™ pile and coal piles areas were observed with gravel, dust, Aggremax™, and coal, and lacked housekeeping. **Pictures 12-14** depict this finding.

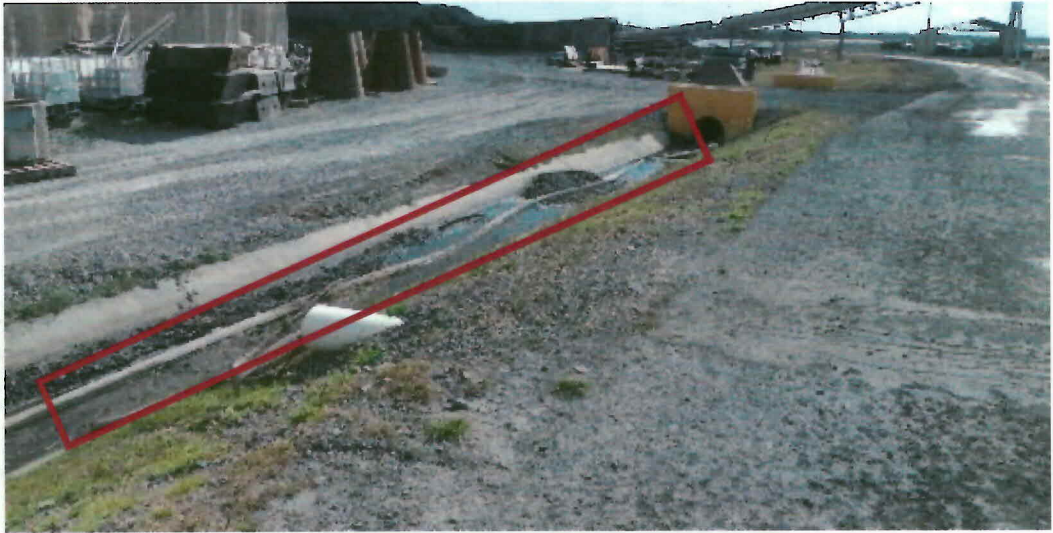
Picture 13¹⁰

¹⁰ The PVC pipeline shown of the photo constituted an illegal connection. This pipeline would carry process wastewater into the Storm Water Runoff Pond.

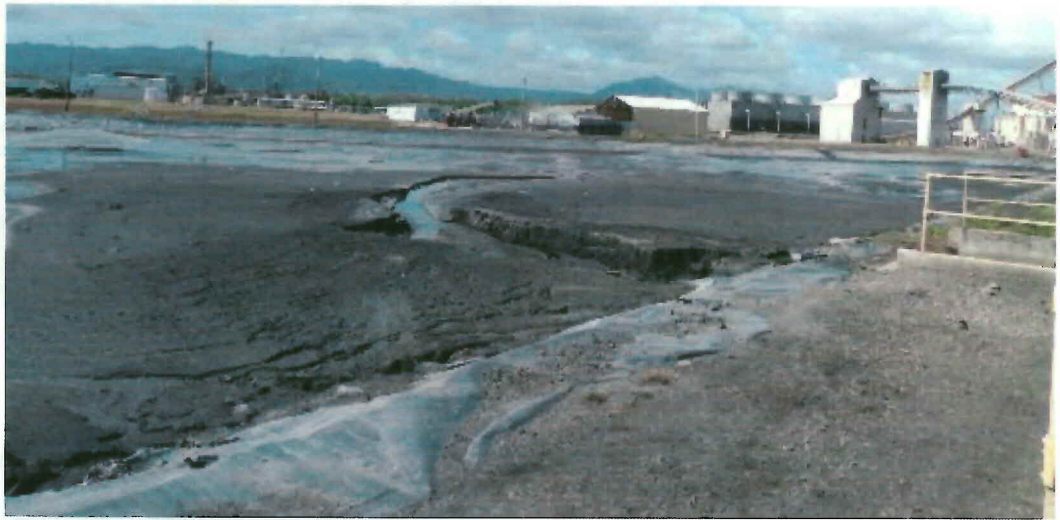
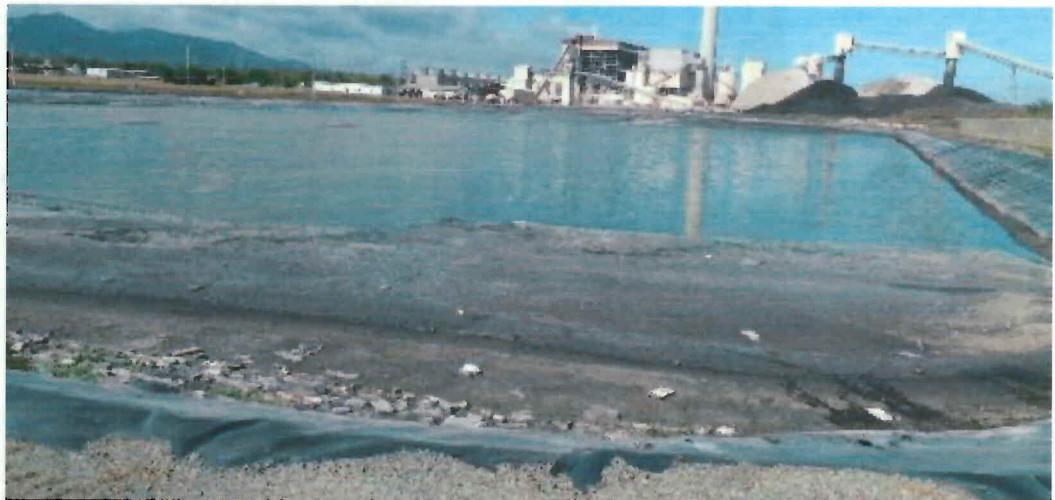
- 3) **Finding:** AES was in the process of emptying the Coal Pile Pond for cleaning and repair, which is a required maintenance activity to eliminate overflow discharges of storm water and process wastewater into wetlands through outfall 003. AES has failed to complete this task since it was found during the July 2011 CEI. **Pictures 15-16** depict this finding.

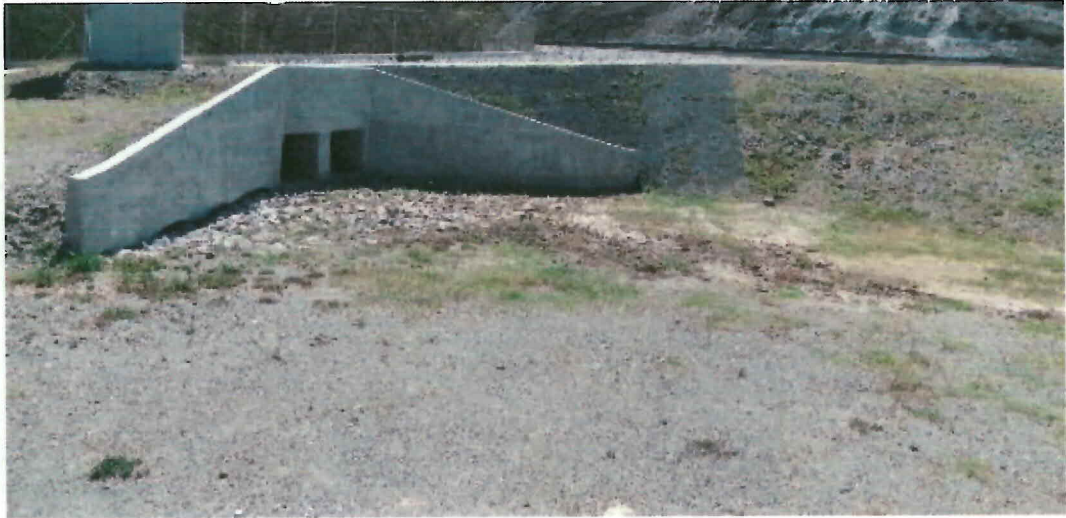
Picture 17

- 1) **Finding:** There was exposed soil without adequate stabilization within the southeast corner of the Site, near the concrete culvert that discharges through outfall 002. **Picture 17** depicts this finding.

- d. **Requirement: Erosion and Sediment Controls** (Part 2.1.2.5) – Stabilize exposed areas and contain runoff using structural and/or non-structural BMPs to minimize on-site erosion and sedimentation, and the resulting discharge of pollutants. Place flow velocity dissipation devices at discharge locations and within outfall channels where necessary to reduce erosion and/or settle out pollutants.

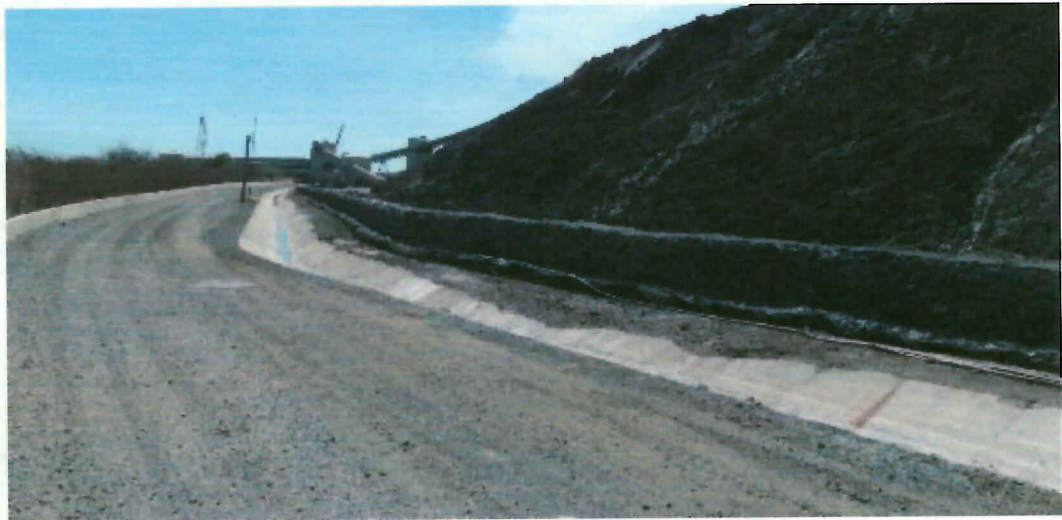
Picture 18

- 2) **Finding:** The dirt road that borders the south boundary of the Site was found without adequate soil stabilization. Traffic on this road was causing excessive fugitive dust emission into the air and adjacent wetlands fallout. **Picture 18** depicts this finding.

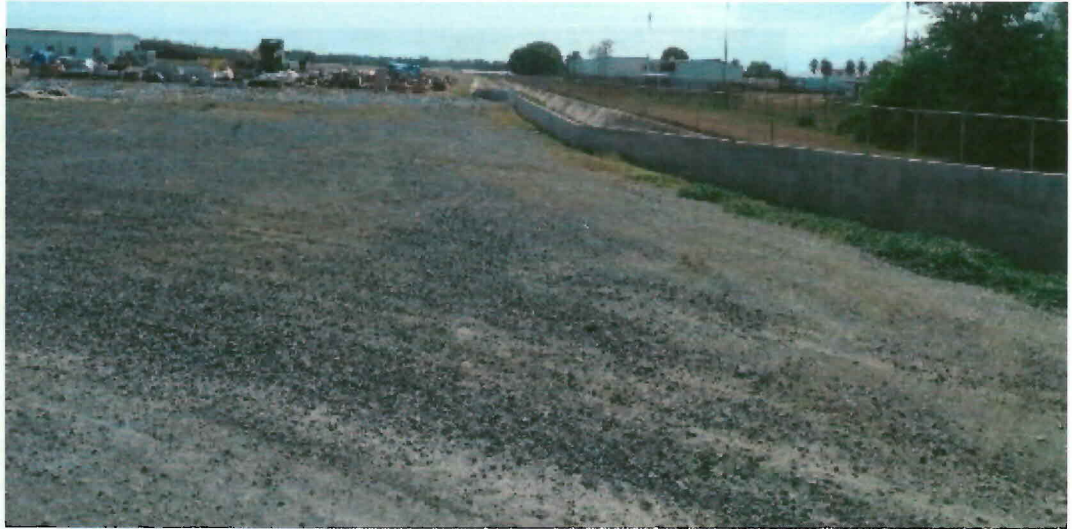
Picture 19

- 3) **Finding:** Several plant yards were observed with inadequate soil stabilization. For example, the yards between the cooling tower and

maintenance shop building were found in such condition, as depicted in **Picture 19**.

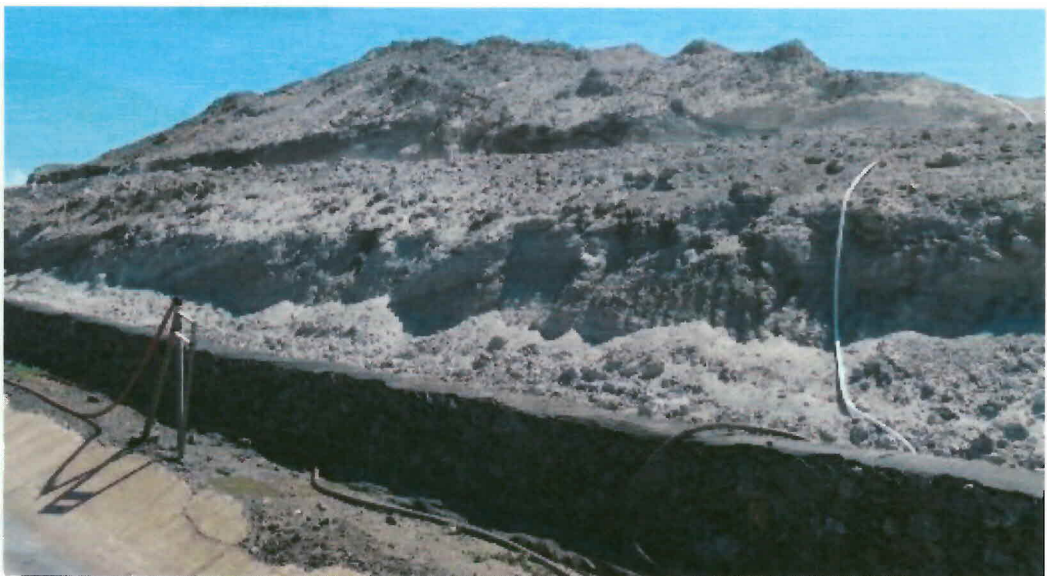
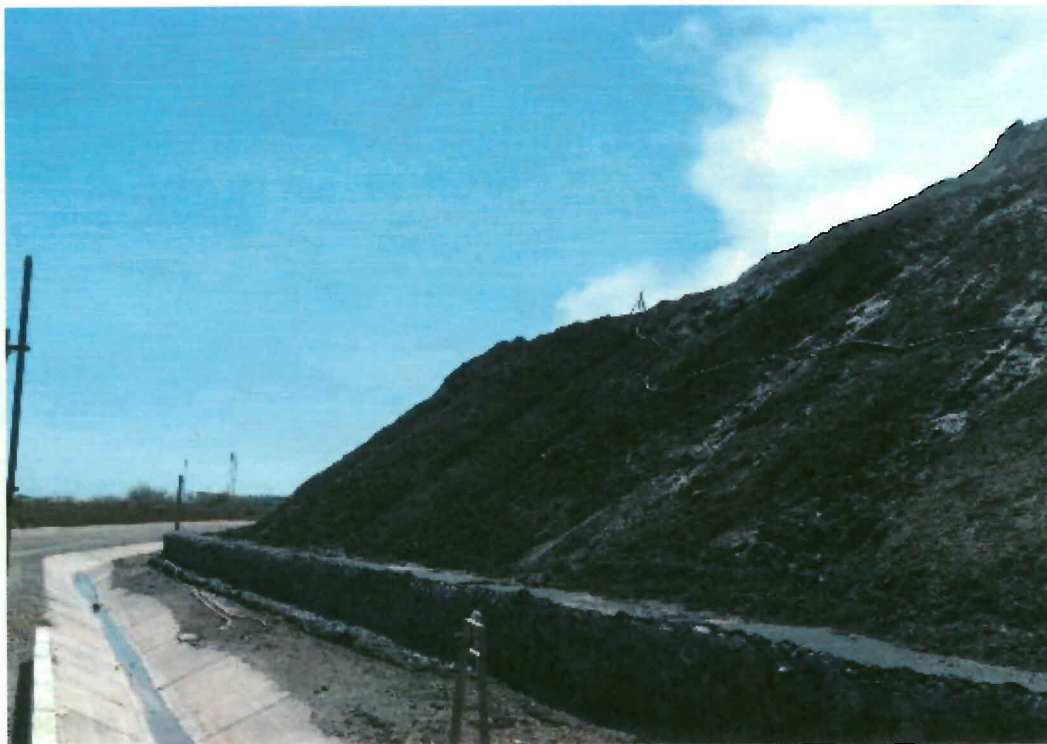
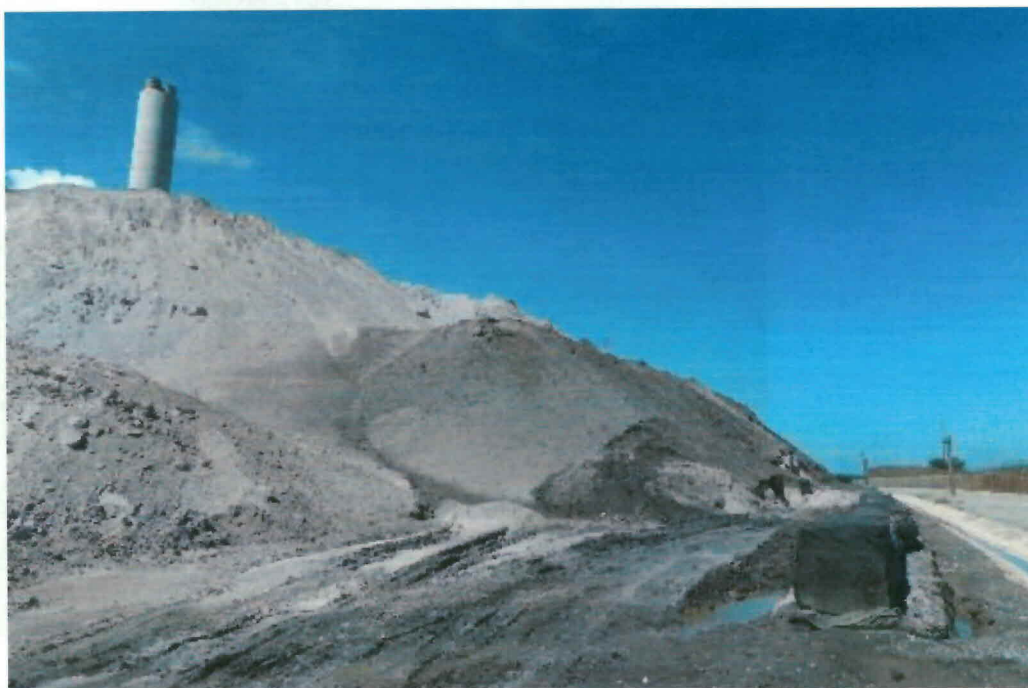
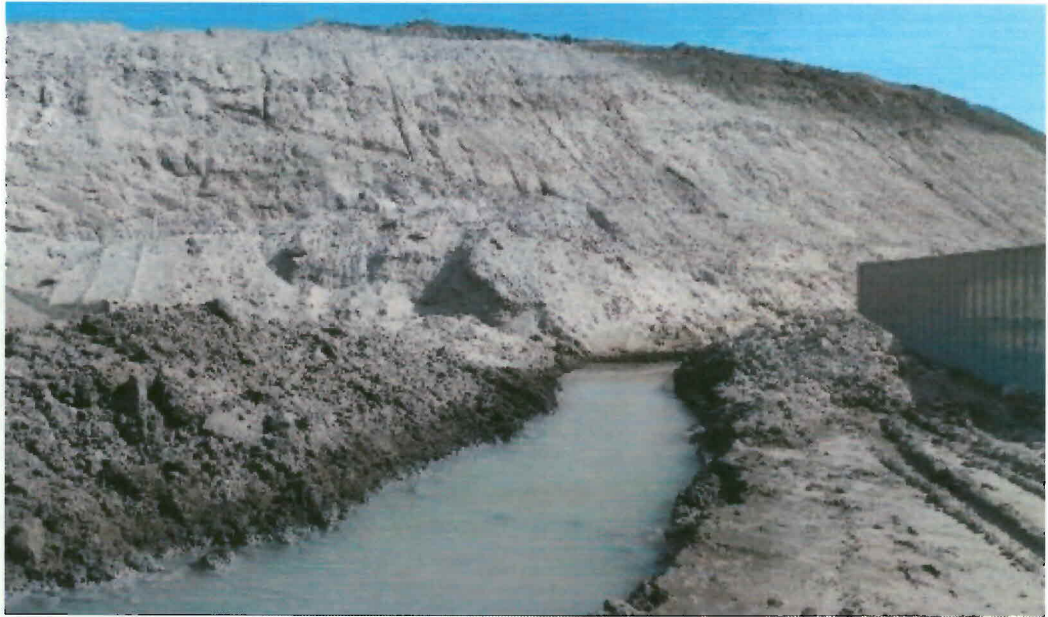
- 4) **Finding:** Slope stabilization and storm water management are not provided in the Aggremax™ storage pile and in some slopes of the coal storage piles. **Pictures 20-25** depict this findings.

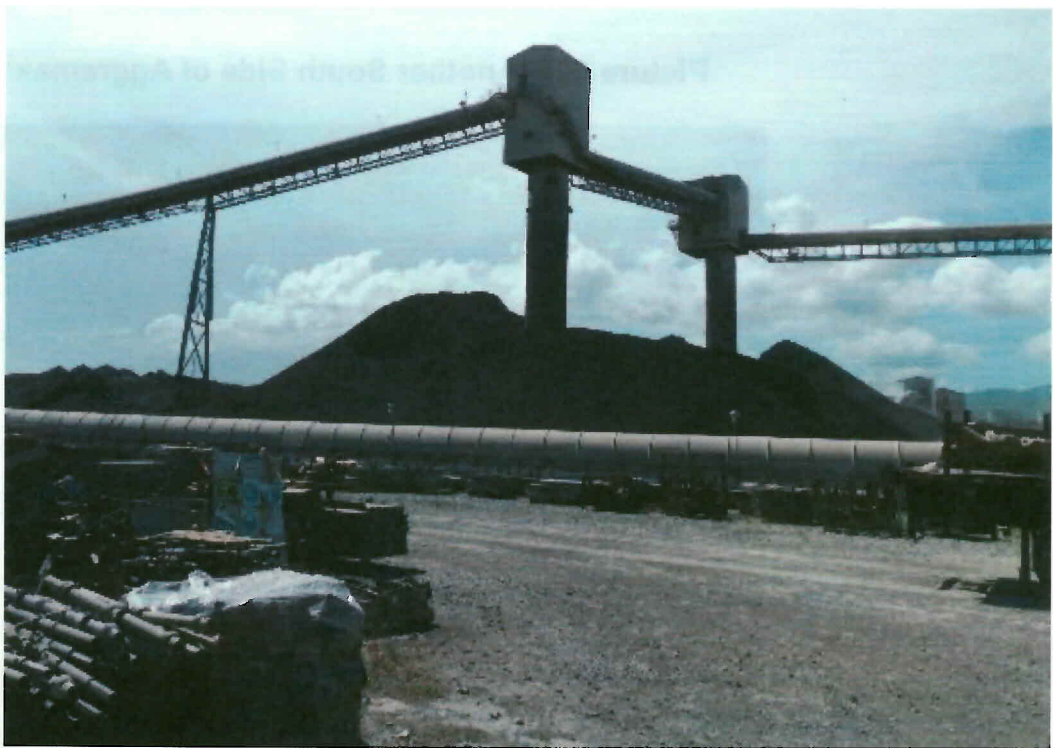
Picture 24 – South Side of Coal Storage Piles¹¹

¹¹ This photograph also depicts inadequate soil stabilization (e.g., insufficient crushed stone soil coverage) and inadequate dust control (e.g., lack of water sprinklers).

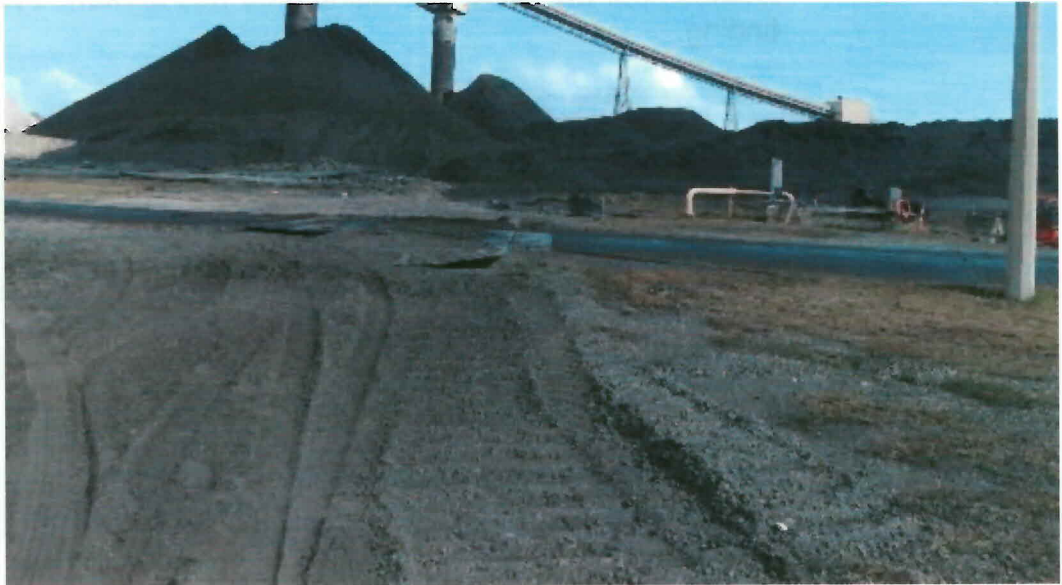
Picture 25 – North Side of Coal Storage Piles¹²

¹² This photograph also depicts coal off-site tracking into plant yard areas and fine soils without dust and stabilization controls.

- 1) **Finding:** See **Picture 25** above for example of coal off-site tracking.
- 4) **Finding:** Off-site tracking of what appears to be Aggremax™ fine particles was observed at the wetlands (outfall 002). **Picture 29** depicts this finding.

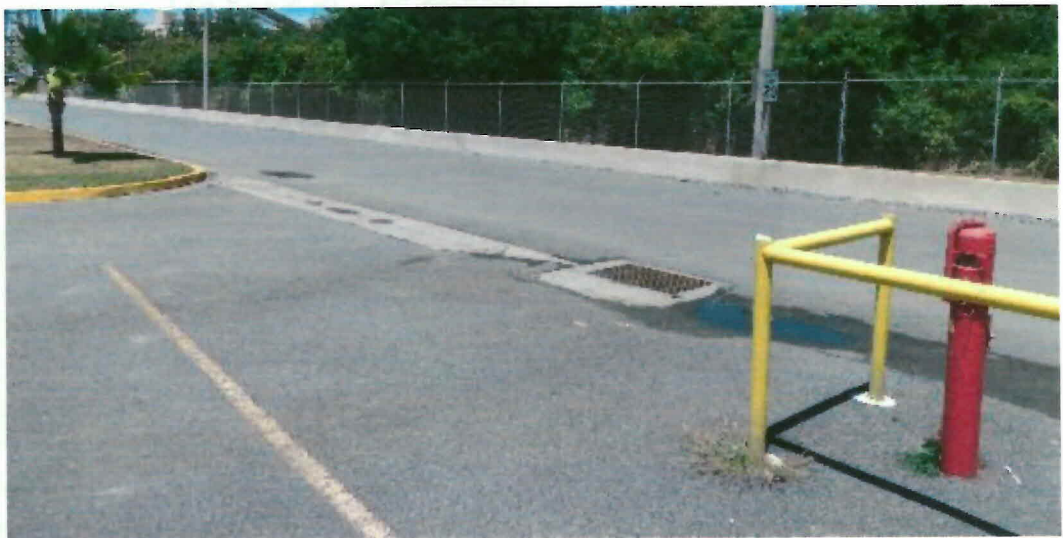
Picture 26

- e. **Requirement: Management of Runoff** (Part 2.1.2.6) – Divert, infiltrate, reuse, contain, or otherwise reduce storm water runoff, to minimize pollutants in the discharges.
- 1) **Finding:** The EPA Inspectors found that the storm water Inlets did not have inlet protection. **Picture 26** depicts this finding.

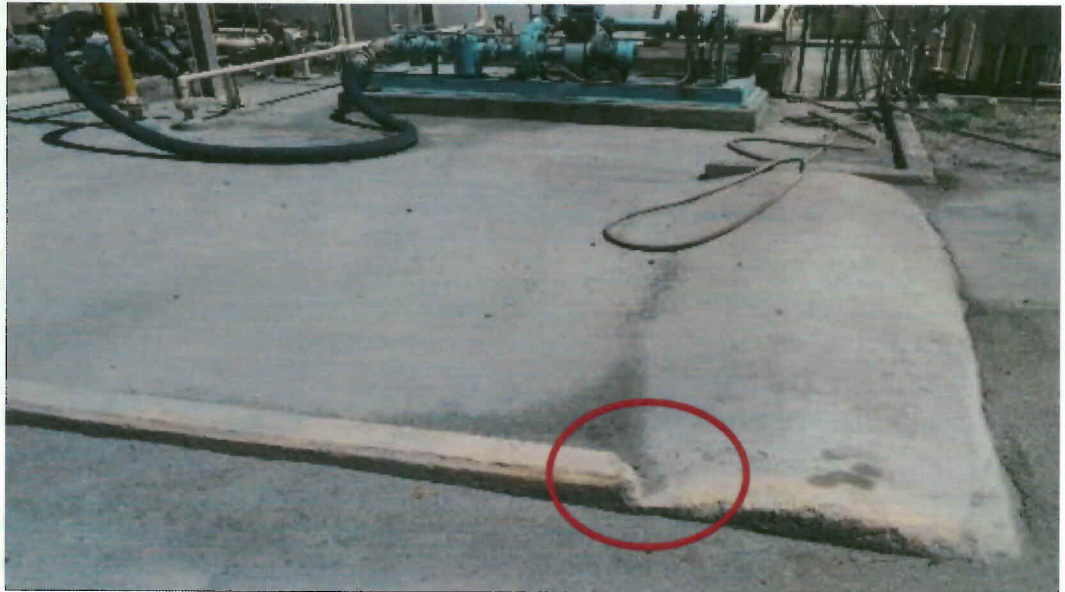
Picture 27

- 2) **Finding:** One (1) corner of the concrete low wall secondary containment located near the diesel unloading area was broken. **Picture 27** depicts this finding.

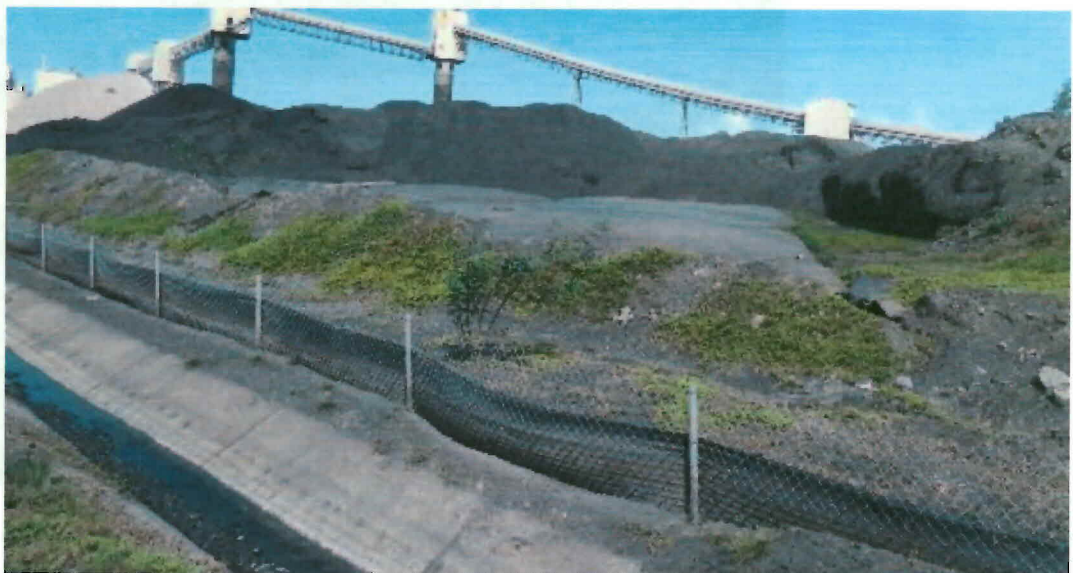
Picture 27 – In Need of Replacement

- 3) **Finding:** AES has not replaced and/or installed silt fence at the perimeter of the coal storage piles and coal handling areas. **Pictures 27-28** depict this finding.

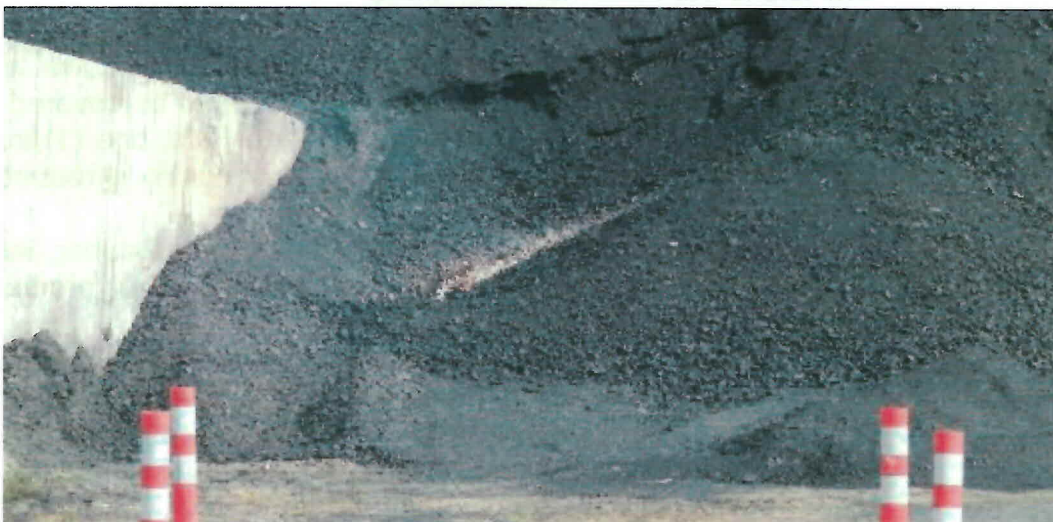
Picture 28 – Lack of Silt Fence at Perimeter¹³

¹³ This photograph also depicts spontaneous coal combustion at coal storage pile.

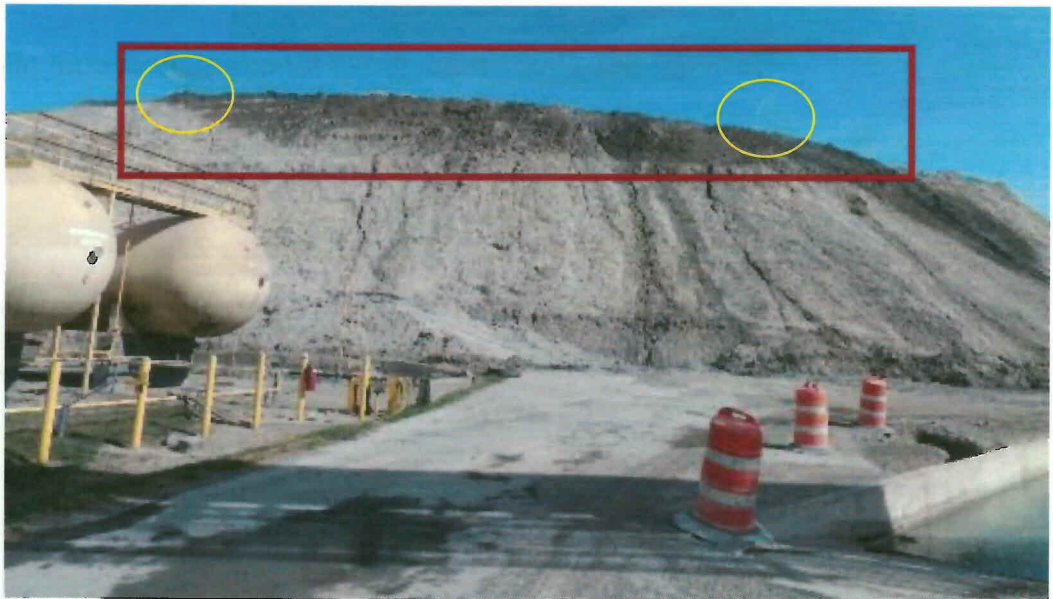
Picture 30

- 2) **Finding:** Fugitive emissions were observed during the entire Inspection's walkthrough, especially in areas in which ashes are handled.
- 3) **Finding:** AES lacks an adequate and effective dust control system for the Aggremax™ storage pile. Although few hoses were feeding water to several sprinklers located on the top side areas of the slopes, most of the slopes were dry and emitting fugitive dust caused by wind. **Picture 30** depicts two (2) sprinklers at the top of the Aggremax™ storage pile (north side of pile), but most of the slope were dry and the sprinkled water could reach the entire length of the slope.
